Manhole Inspection Summary

Manhole # S21E1_016MH

Location Address: **2653 ridgely-huron alley**

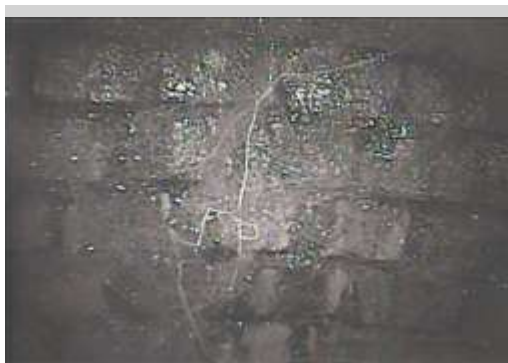
Defect 5

Condition: ☐ Sound ☐ Cracked ☒ **Root Intrusion** ☐ Loose Brick ☐ Deteriorated

root intrusion @ barrel wall

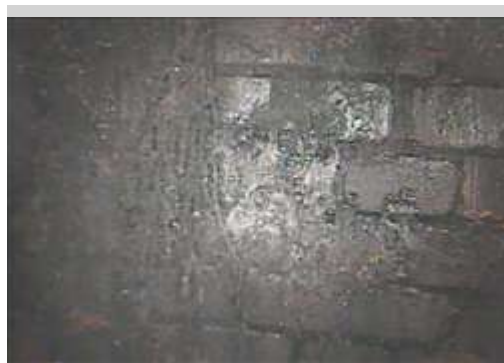
Defect 4

Infiltration: ☐ None ☐ Joint ☐ Cracks ☐ Mortar ☐ Roots ☒ **Wall**

infiltration @ barrel wall

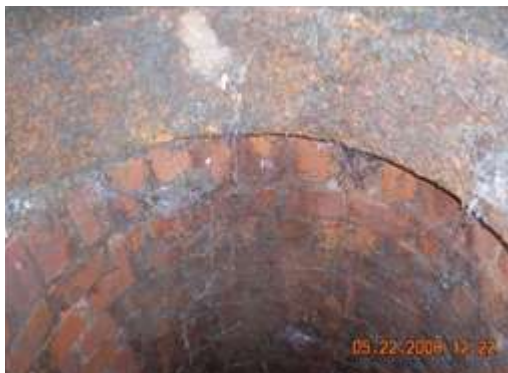
Defect 3

Infiltration: ☐ None ☒ **Joint** ☐ Cracks ☐ Mortar ☐ Roots ☐ Wall

infiltration @ corbel/frame joint

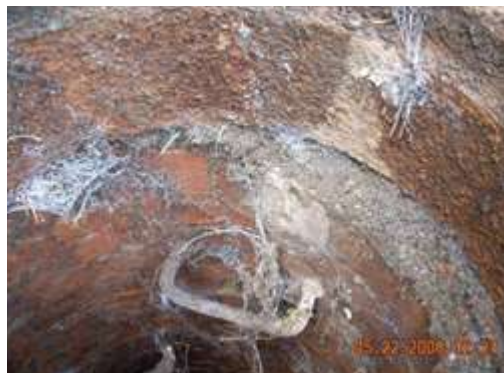
Defect 2

Condition: ☐ Sound ☐ Cracked ☒ **Root Intrusion** ☐ Loose Brick ☐ Deteriorated

root intrusion @ corbel/frame joint

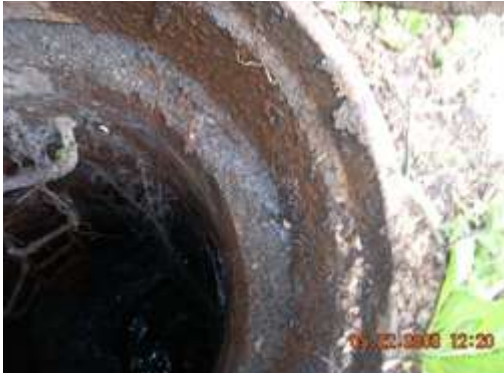
Defect 1

Frame Offset: **2** (in.) Condition: ☒ Sound ☐ Cracked ☐ Leaks

frame offset

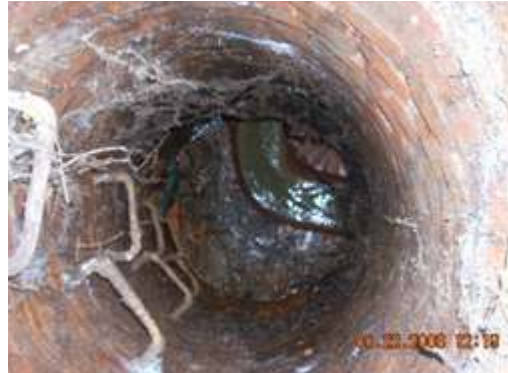
Defect 6

Steps Count: **7** Missing: **0** ☒ **Corroded**

steps corroded

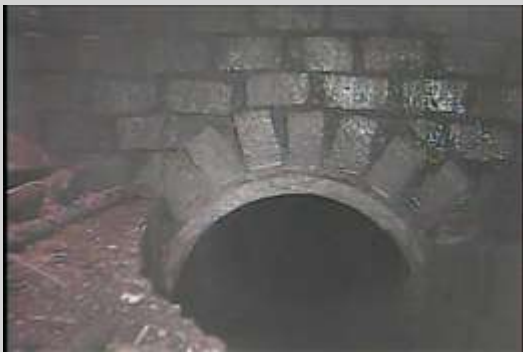
12 O'Clock Outflow

15 in. Circular Gravity Sewer
Pipe Out @ 12 O'Clock

Pipe Height: **15.6** (in.) Rod and Bar (Angled)
Pipe Material: **Clay** ☐ Pipe Lined
Invert Depth: **12.93** (ft.) Flow Characteristics: **Slow**
Deposits: ☒ None ☐ Mud ☐ Sludge ☐ Debris ☐ Grease
Silt Depth: **0** (in.) Deposits Extent:
Infiltration: **None** Pipe Seal Cond: **Sound**

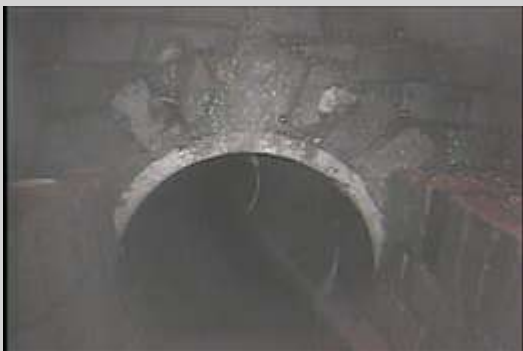
3 O'Clock Inflow

15 in. Circular Gravity Sewer
Pipe In @ 3 O'Clock

Pipe Height: **15.6** (in.) Rod and Bar (Angled)
Pipe Material: **Clay** ☐ Pipe Lined
Invert Depth: **12.80** (ft.) Flow Characteristics: **Slow**
Deposits: ☒ None ☐ Mud ☐ Sludge ☐ Debris ☐ Grease
Silt Depth: **0** (in.) Deposits Extent:
Infiltration: **None** Pipe Seal Cond: **Sound**
